IDDE  
INSPECTION  
SUMMARY  
REPORT

**2024 Illicit Discharge Detection & Elimination Inspection Summary Report**  
*December 2024*

**City of Greenfield**  
7325 West Forest Home Avenue  
Greenfield, WI 53220

**Ruekert & Mielke, Inc.**  
W233 N2080 Ridgeview Parkway  
Suite 300  
Waukesha, WI 53188

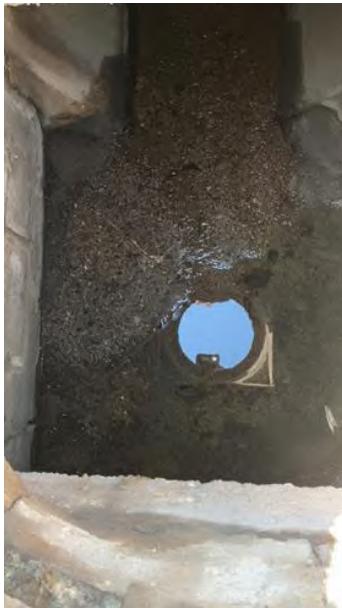
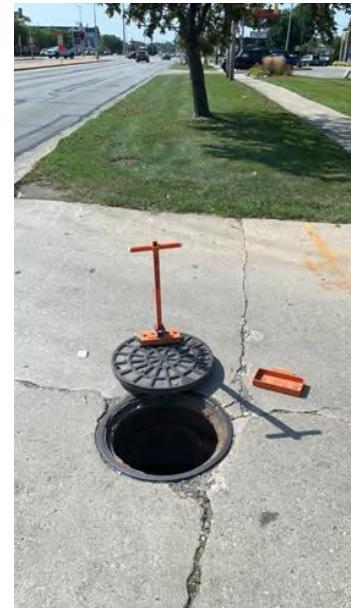
Outfall K015 consists of one 42-inch diameter concrete storm sewer pipe. At the time of inspection this outfall was flowing; therefore, a sample was taken and tested. The test results registered negative/neutral in all instances other than detergent, which registered at 0.25 mg/L. Accumulated sediment was noted in the flow line.

INDICATOR	DESCRIPTION	INDICATOR	DESCRIPTION
<input type="checkbox"/> Odor	<input type="checkbox"/> Sewage <input type="checkbox"/> Rancid/Sour <input type="checkbox"/> Petroleum/Gas <input type="checkbox"/> Sulfide <input type="checkbox"/> Other:	<input type="checkbox"/> Outfall Damage	<input type="checkbox"/> Spalling, Cracking or Chipping <input type="checkbox"/> Corrosion <input type="checkbox"/> Peeling Paint <input type="checkbox"/> Trash Rack Damage <input type="checkbox"/> Other:
<input type="checkbox"/> Color	<input type="checkbox"/> Clear <input type="checkbox"/> Brown <input type="checkbox"/> Gray <input type="checkbox"/> Yellow <input type="checkbox"/> Green <input type="checkbox"/> Orange <input type="checkbox"/> Red <input type="checkbox"/> Other:	<input checked="" type="checkbox"/> Deposits or Stains	<input type="checkbox"/> Oily <input type="checkbox"/> Paint <input type="checkbox"/> Flow Line <input checked="" type="checkbox"/> Other: Accumulated sediment in the flow line.

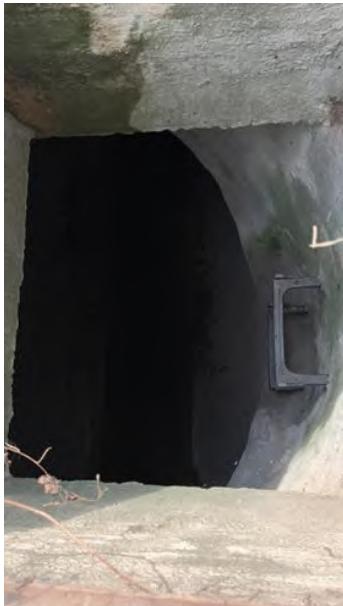
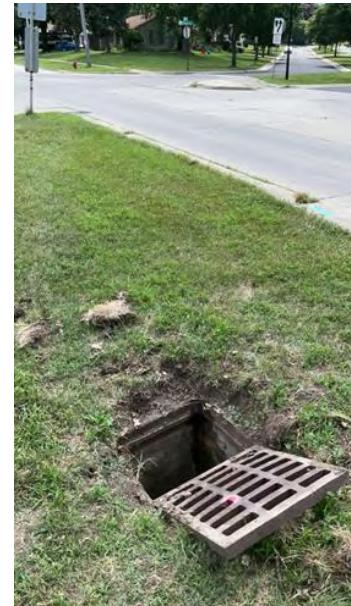
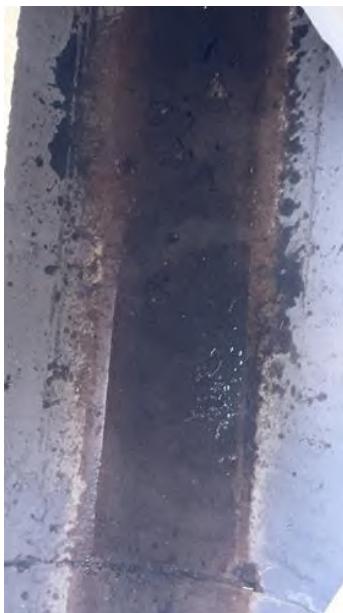
Outfall K044 consists of one 48-inch diameter concrete storm sewer pipe. At the time of inspection this outfall was flowing; therefore, a sample was taken and tested. At the time of inspection this outfall was flowing and tested. The test results registered negative/neutral in all instances other than detergent, which registered at 0.25 mg/L.

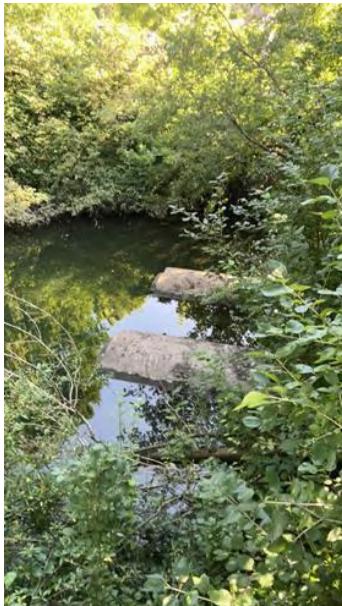
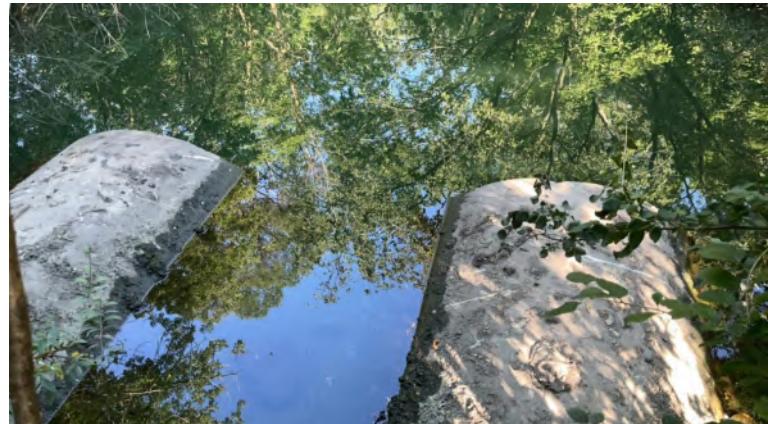
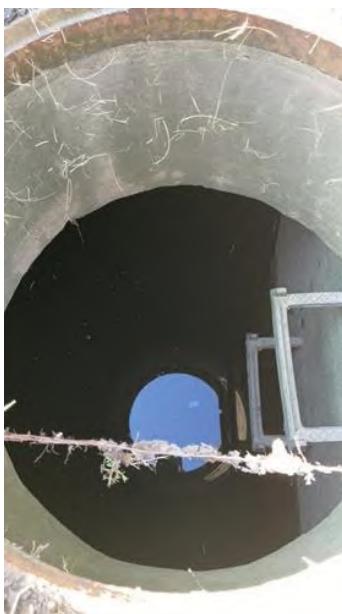
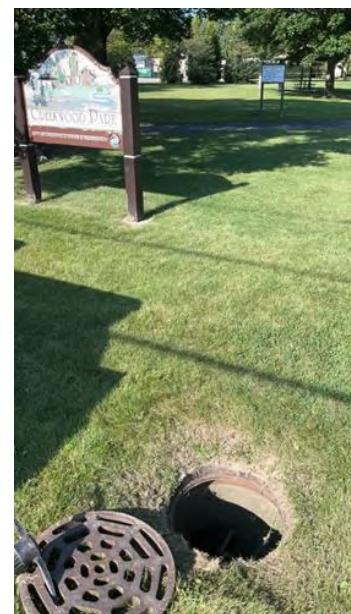
Outfall M001 consists of dual 60-inch round concrete storm sewer pipes. This outfall was submerged by 54-inches. The inspector was unable to determine if flow was present at the outfall; therefore, the next upstream manhole was inspected to determine flow. This upstream pipe was flowing, and a sample was taken and tested. The test results registered negative/neutral in all instances. Spalling, cracking or chipping at the outfall was noted as well as an odor from the pool.

This outfall was submerged. Flow was verified at the nearest upstream manhole, therefore, a sample was collected. Additional samples were collected and delivered to the Wisconsin State Laboratory of Hygiene for E. coli testing. Test results are provided in the corresponding summary report.

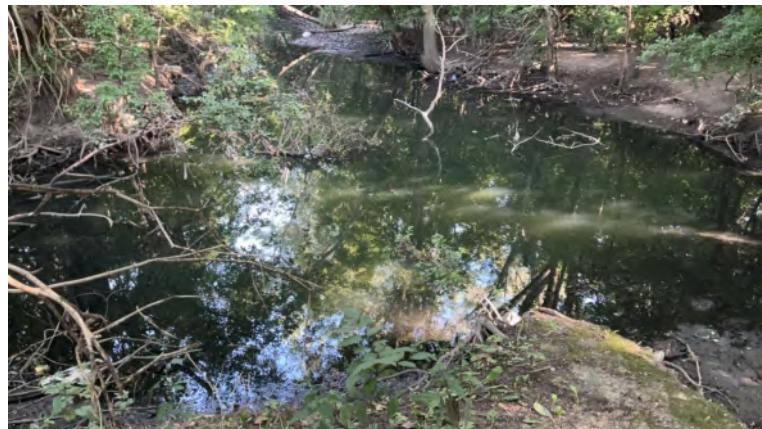
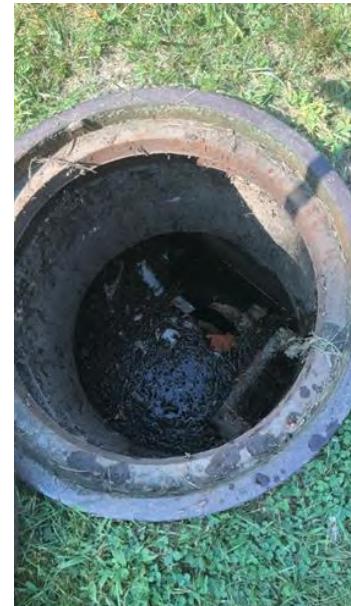
<input type="checkbox"/> Turbidity	<input type="checkbox"/> 1 - Slight Cloudiness <input type="checkbox"/> 2 - Cloudy <input type="checkbox"/> 3 - Opaque	<input type="checkbox"/> Abnormal Vegetation	<input type="checkbox"/> Excessive <input type="checkbox"/> Inhibited <input type="checkbox"/> Woody Growth
<input type="checkbox"/> Floatables	<input type="checkbox"/> Sewage (Toilet Paper, etc.) <input type="checkbox"/> Suds <input type="checkbox"/> Petroleum (Oil Sheen) <input type="checkbox"/> Other:	<input checked="" type="checkbox"/> Poor Pool Quality	<input type="checkbox"/> Odors <input type="checkbox"/> Yellow <input type="checkbox"/> Floatables <input type="checkbox"/> Oil Sheen <input type="checkbox"/> Excessive Algae <input type="checkbox"/> Suds <input checked="" type="checkbox"/> Other: Garbage present in the nearest upstream manhole.

Outfall was completely submerged and was not visible. The next upstream manholes were completely submerged as well, with no apparent flow.

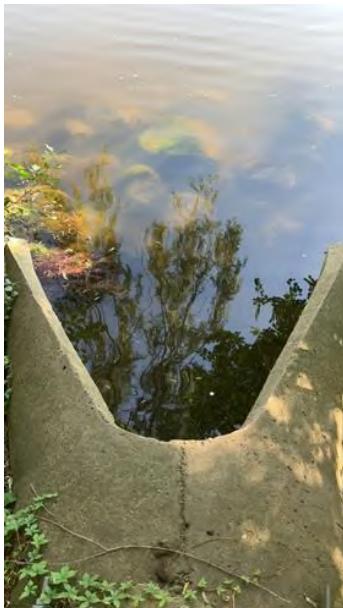
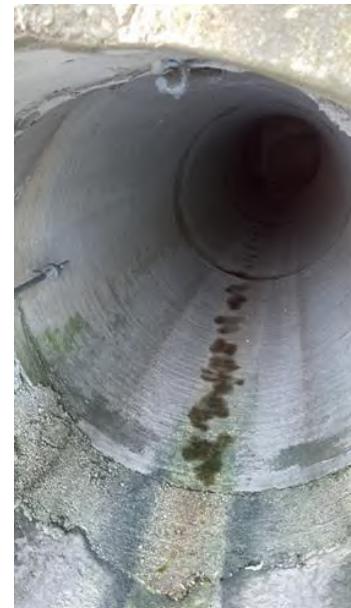
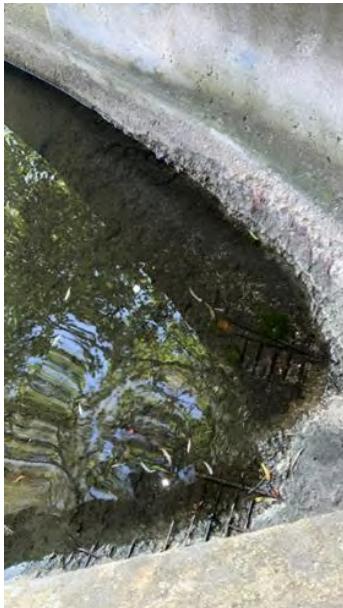
The end section had exposed rebar.

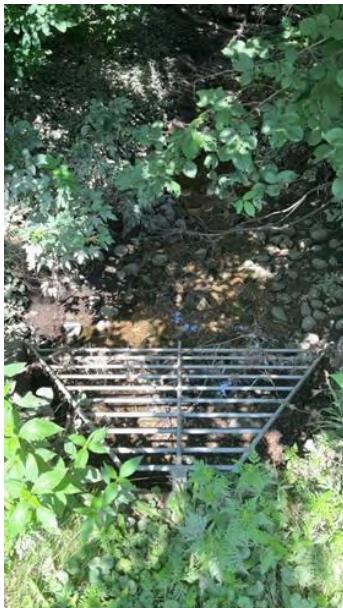
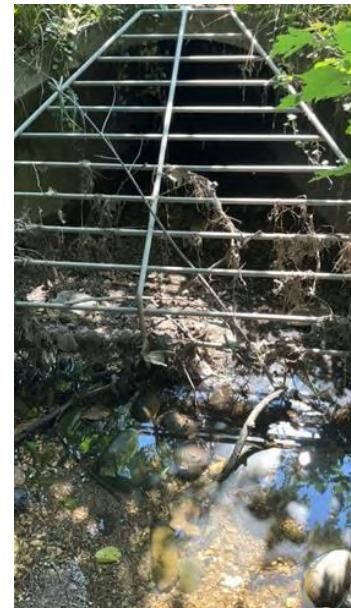
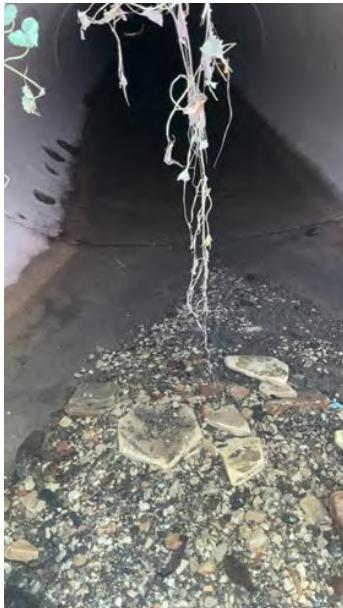
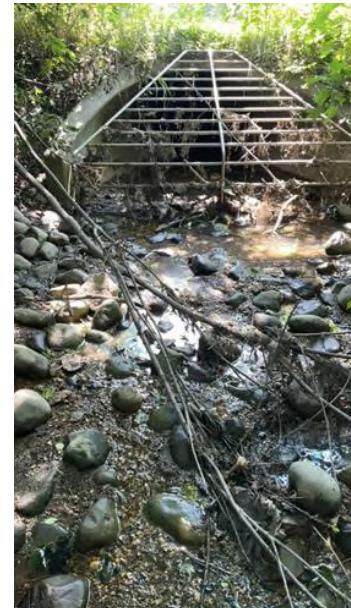
Outfall R057 consists of one 38x60-inch concrete storm sewer pipe. At the time of inspection this outfall was flowing; therefore, a sample was taken and tested. The test results registered negative/neutral in all instances other than detergent, which registered at 0.25 mg/L. Spalling, cracking or chipping at the outfall was noted as well as approximately 3-inches of gravel present within the flow line.

INDICATOR	DESCRIPTION	INDICATOR	DESCRIPTION
<input type="checkbox"/> Odor	<input type="checkbox"/> Sewage <input type="checkbox"/> Rancid/Sour <input type="checkbox"/> Petroleum/Gas <input type="checkbox"/> Sulfide <input type="checkbox"/> Other:	<input type="checkbox"/> Outfall Damage	<input checked="" type="checkbox"/> Spalling, Cracking or Chipping <input type="checkbox"/> Corrosion <input type="checkbox"/> Peeling Paint <input type="checkbox"/> Trash Rack Damage <input type="checkbox"/> Other:
<input type="checkbox"/> Color	<input type="checkbox"/> Clear <input type="checkbox"/> Brown <input type="checkbox"/> Gray <input type="checkbox"/> Yellow <input type="checkbox"/> Green <input type="checkbox"/> Orange <input type="checkbox"/> Red <input type="checkbox"/> Other:	<input type="checkbox"/> Deposits or Stains	<input type="checkbox"/> Oily <input type="checkbox"/> Paint <input type="checkbox"/> Flow Line <input checked="" type="checkbox"/> Other: Up to 3 inches of gravel is in the flow line.

Flow was partially restricted by gravel in the end section and within the the flowline immediately downstream of the outfall.

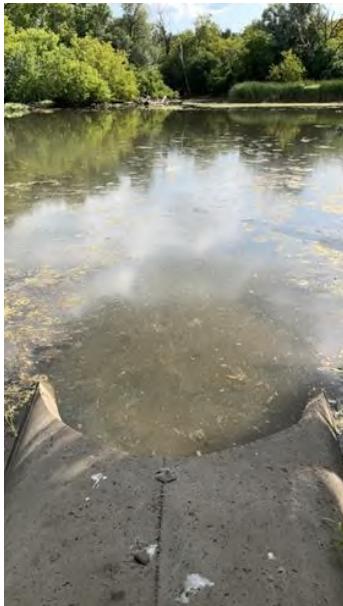
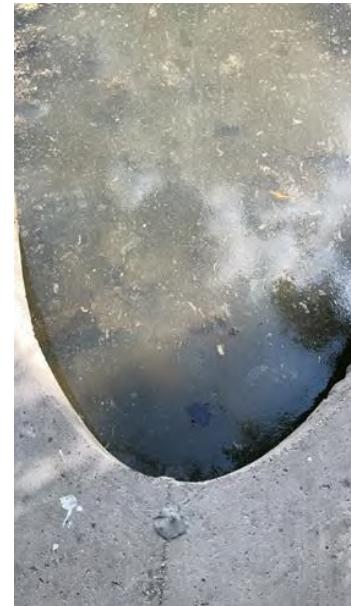
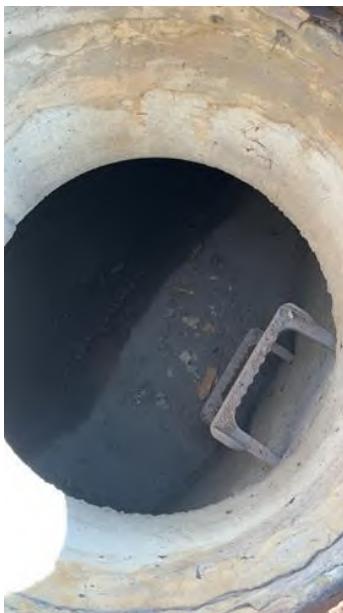
This outfall was submerged. The nearest upstream manhole cover could not be opened at the time of inspection and the City was notified. The City DPW was able to open the manhole cover. This manhole was reinspected on 8/21 and there was no apparent flow.

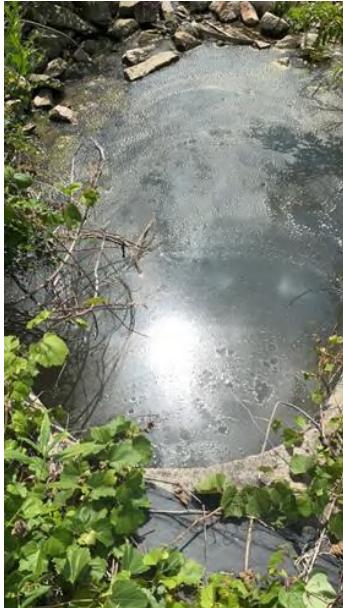
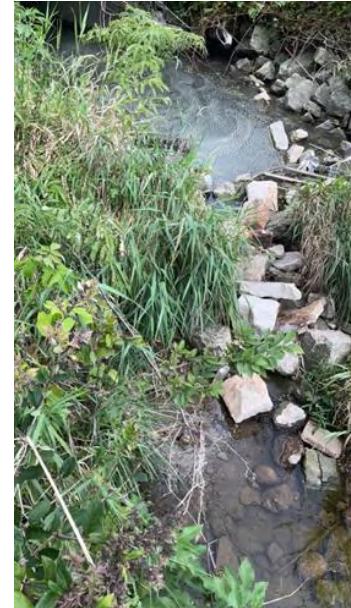
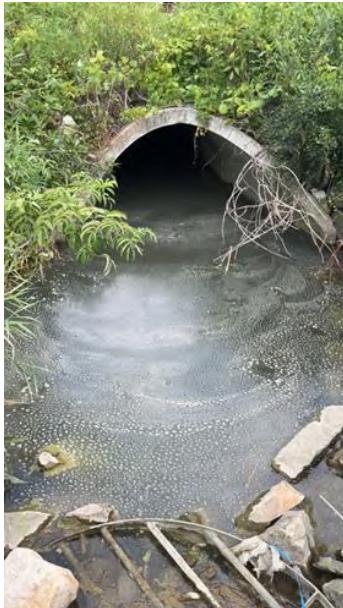
Outfall R091 consists of one 60-inch diameter concrete storm sewer pipe. At the time of inspection, this outfall was flowing; therefore, a sample was taken and tested. The test results for this outfall registered negative/neutral in all instances other than detergent, which registered at 0.25 mg/L. Suds and surface scum were present in the flow and the pool.

Flow from this outfall discharges to a small pool. The flow then splits into two smaller channels approximately 12 feet from the outfall pipe. Flow is partially restricted by riprap and where ground where it splits. The clarity of the flow was clear where it splits into the two smaller channels. A sample was collected approximately a foot below the flow surface at the pipe opening.

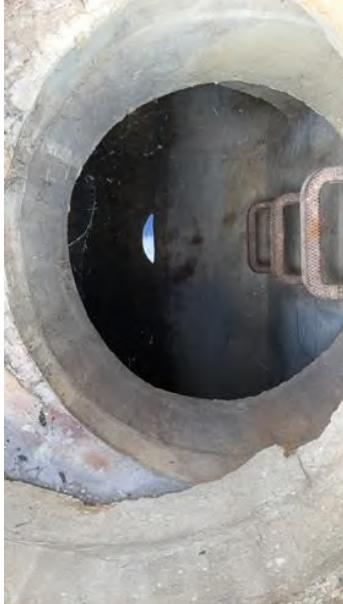
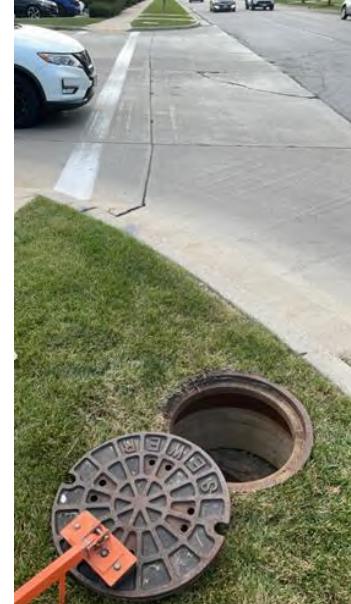
Outfall R146 consists of one 48-inch diameter concrete storm sewer pipe. At the time of inspection, this outfall was flowing; therefore, a sample was taken and tested. The test results for this outfall registered negative/neutral in all instances other than detergent, which registered at 0.25 mg/L.

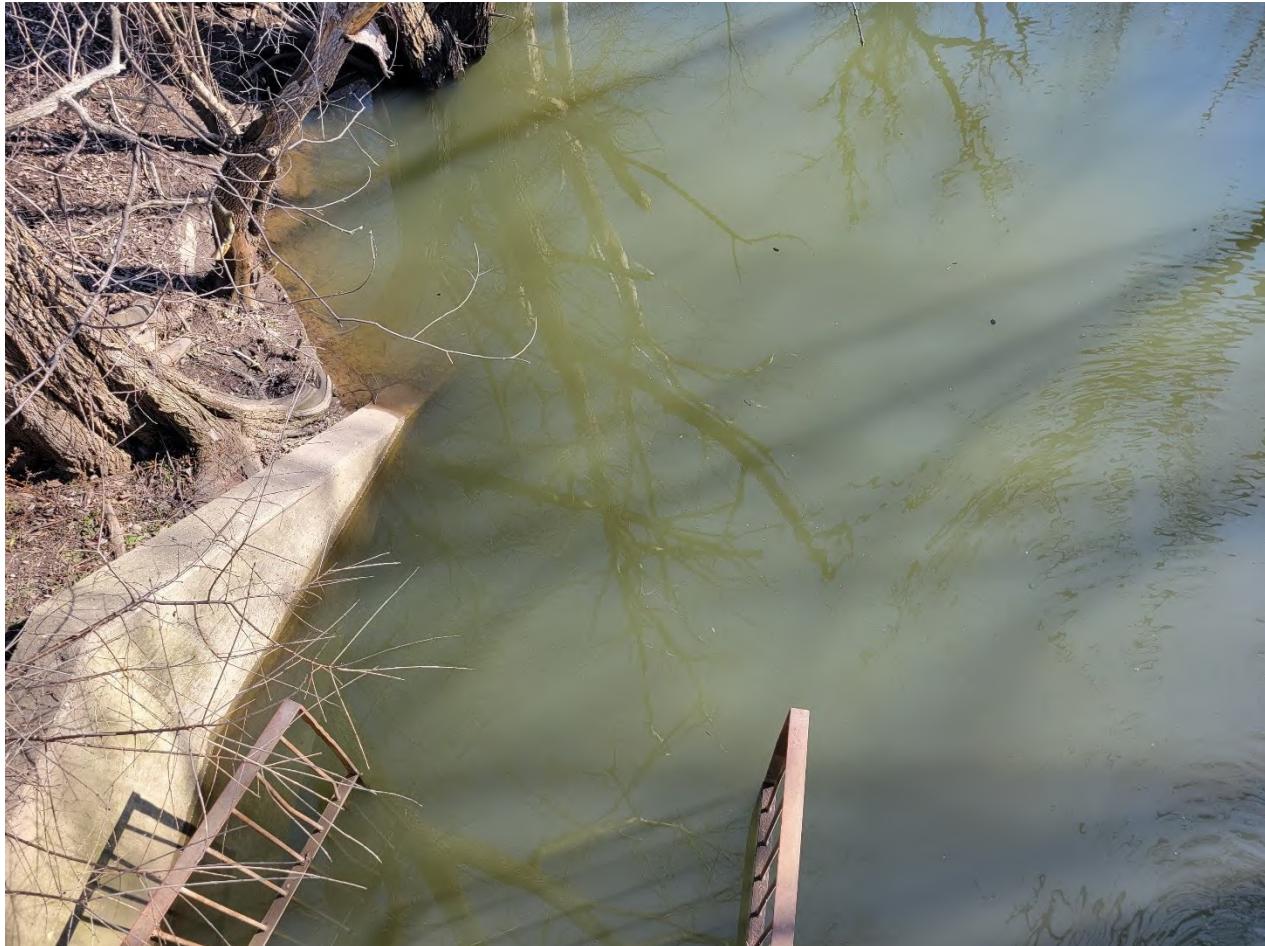
## Event 1

A diesel fuel spill on I-894 under the S 76<sup>th</sup> St bridge. This was reported to Engineering staff by way of WI DNR Spill Hotline (# 20114 ID 20240205SE41-1). Riley Neumann with the WI DNR was the point of contact for the WI DNR response efforts. Engineering staff provided WI DNR with storm system and storm discharge location information. Spill drained to, and was contained in a WI DOT storm sewer the entire way to its discharge at the Root River. At the request of WI DNR, Engineering staff ran out to inspect the condition of the outfall. This incident was determined to be the responsibility of the WI DOT / WI DNR.

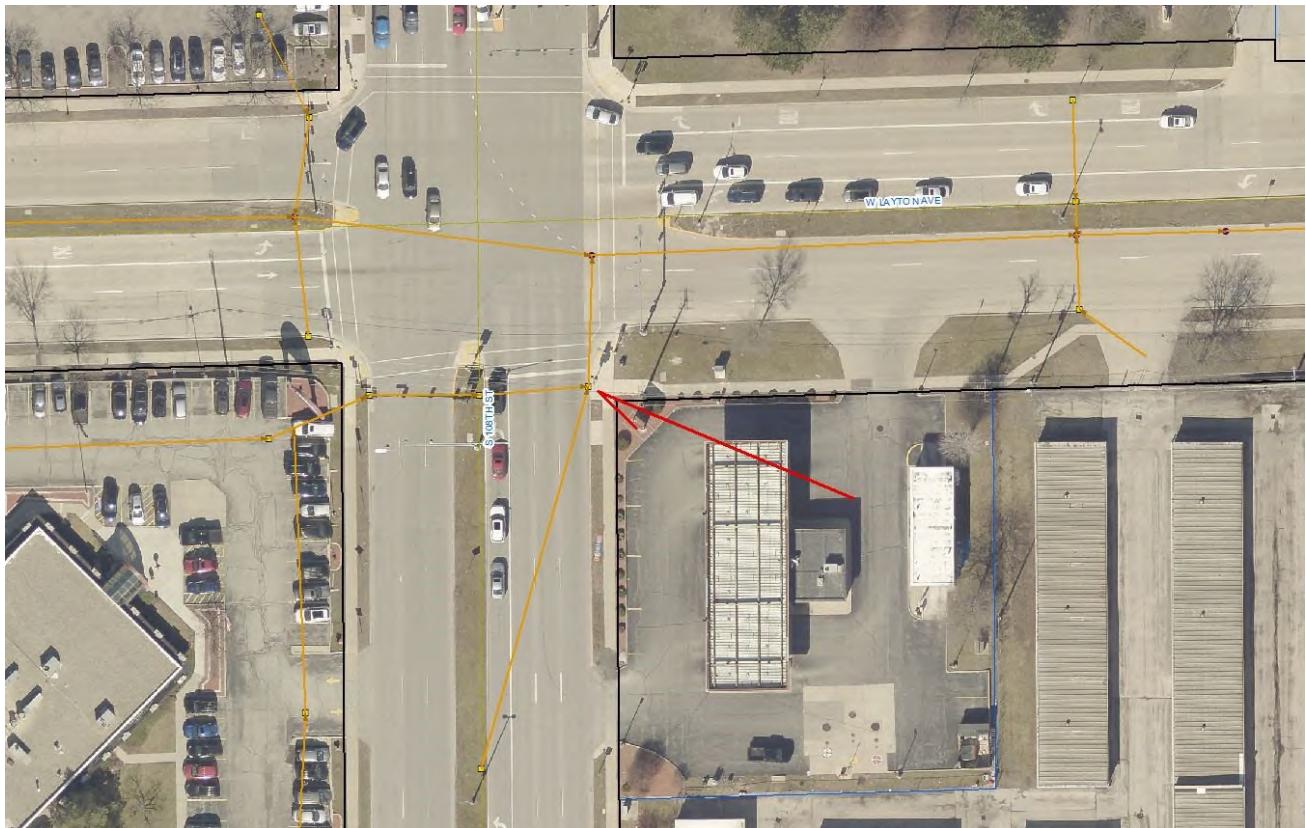
## Event 2

Notification from Milwaukee County about an IDDE hit they discovered as part of their 2023 IDDE testing. Looking into the location identified by Milwaukee County, Engineering staff determine that the storm sewer in question is owned by, and in WI DOT right-of-way. Milwaukee County was notified to contact WI DOT to investigate.

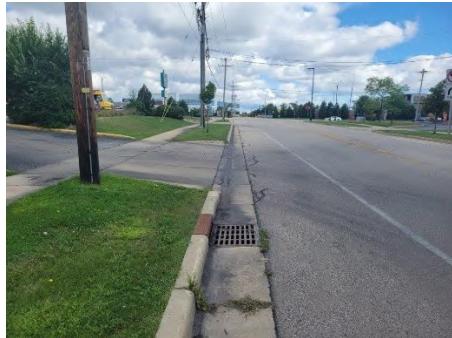
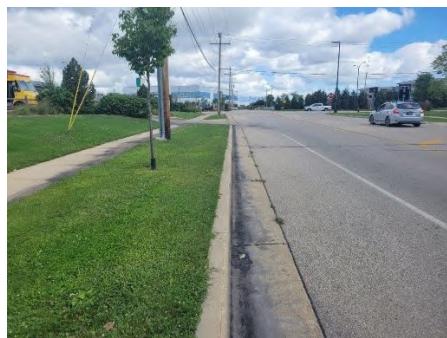
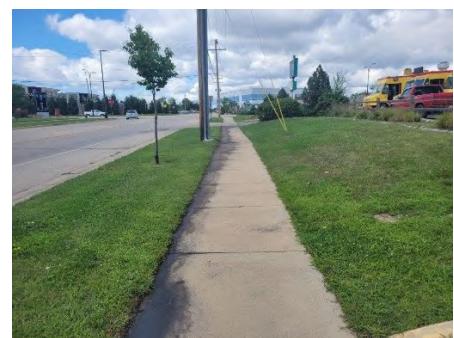
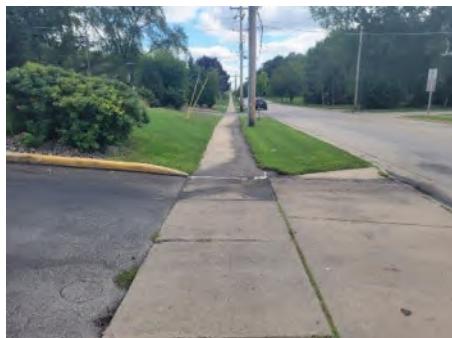
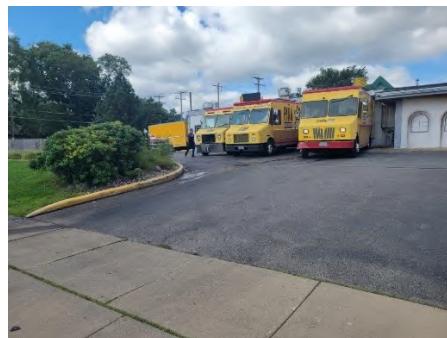
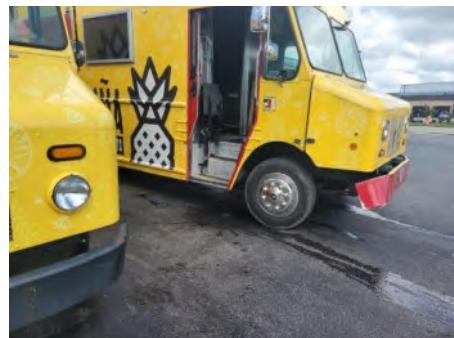
### Event 3

Engineering staff received a complaint from a resident about a local restaurant cleaning their food trucks in the parking lot and the run-off carrying grease onto the sidewalk and into the roadway curb and gutter. Investigation by Engineering staff confirmed what resident reported. City Code Enforcement and Health Department were notified and also followed-up with property owner. The property owner was instructed to stop their cleaning practices that involve a hose that allow wash water to run off the property and to convert to cleaning practices that use a mop to clean the trucks. Property will be monitored.

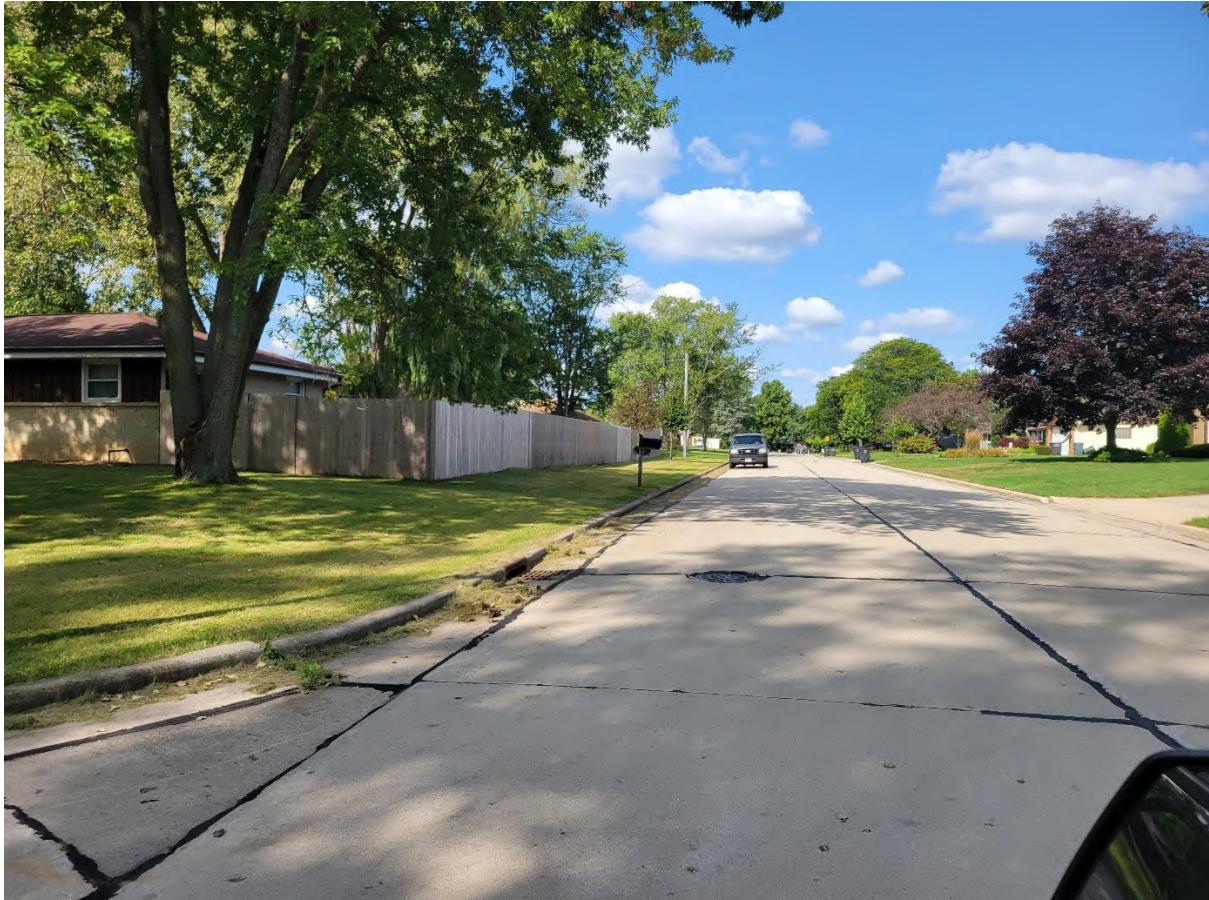
#### Event 4

Engineering staff received a complaint from a resident about a neighbor who cut grass left a large amount of grass clippings in the roadway. Investigation by Engineering staff confirmed what resident reported. Engineering staff sent a letter to the subject property to notify them to stop the practice of discharging excess lawn clippings onto the roadway. It appears that the resident had let the area between the fence and curb grow very tall, and when cutting discharged it to the roadway. This appears to be an isolated incident that we believe has been resolved.

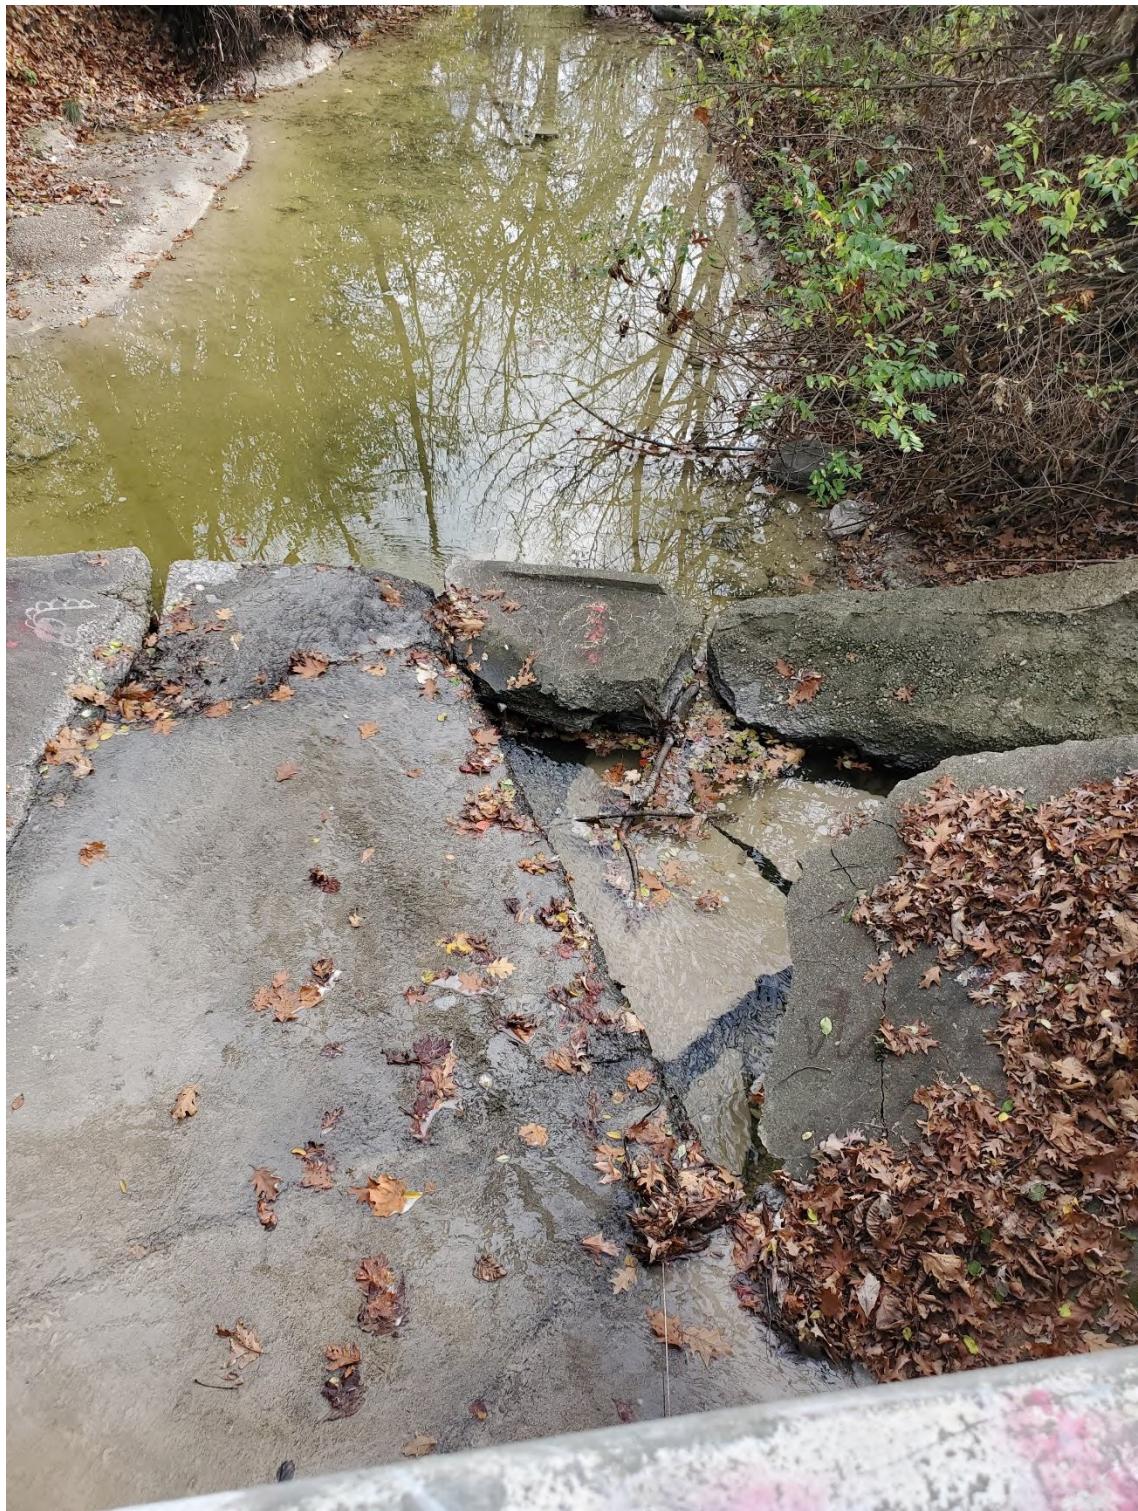
## Event 5

A notification form the WI DNR about an observed discoloration in a creek near 20<sup>th</sup> & Grange. Engineering staff investigated and determined the creek discoloration was a result of runoff form a water main replacement program under the direction of Milwaukee Water Works (MWW). Engineering staff notified MWW to take the necessary corrective action.

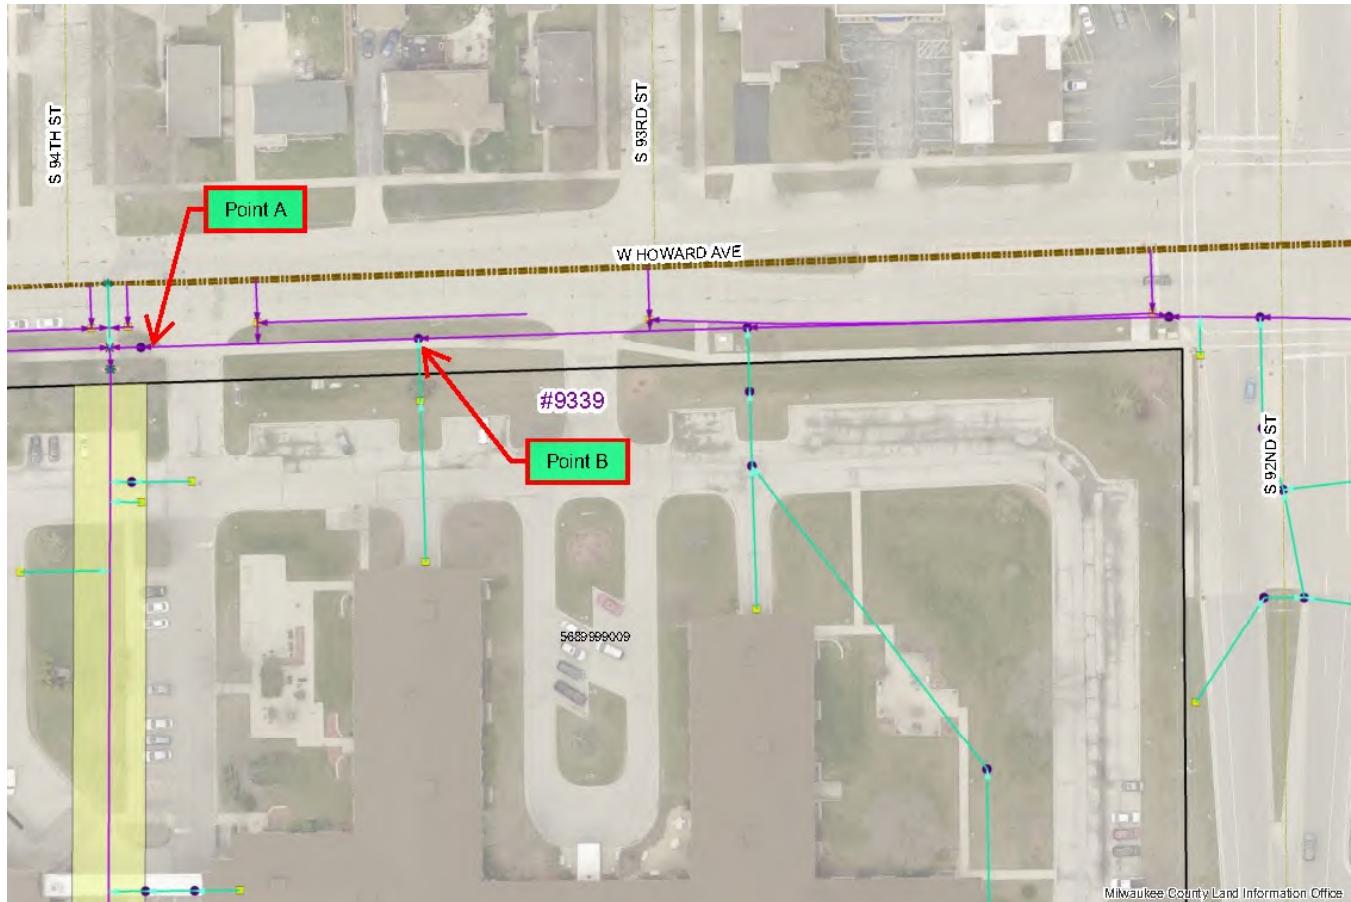
## Event 6

A notification from the City of Milwaukee about a positive chlorine reading they found during their routine testing that was determined to be coming from a Greenfield storm sewer, and more specifically from 9339 W Howard Ave. The initial notice was sent to the City in 2023 and was investigated and resolved at the time. Upon investigating this new notification, it was determined that an email from City of Milwaukee was sent by mistake as a result of a computer glitch, and that City of Milwaukee did not intend to send, and was not aware an additional email was sent in 2024.

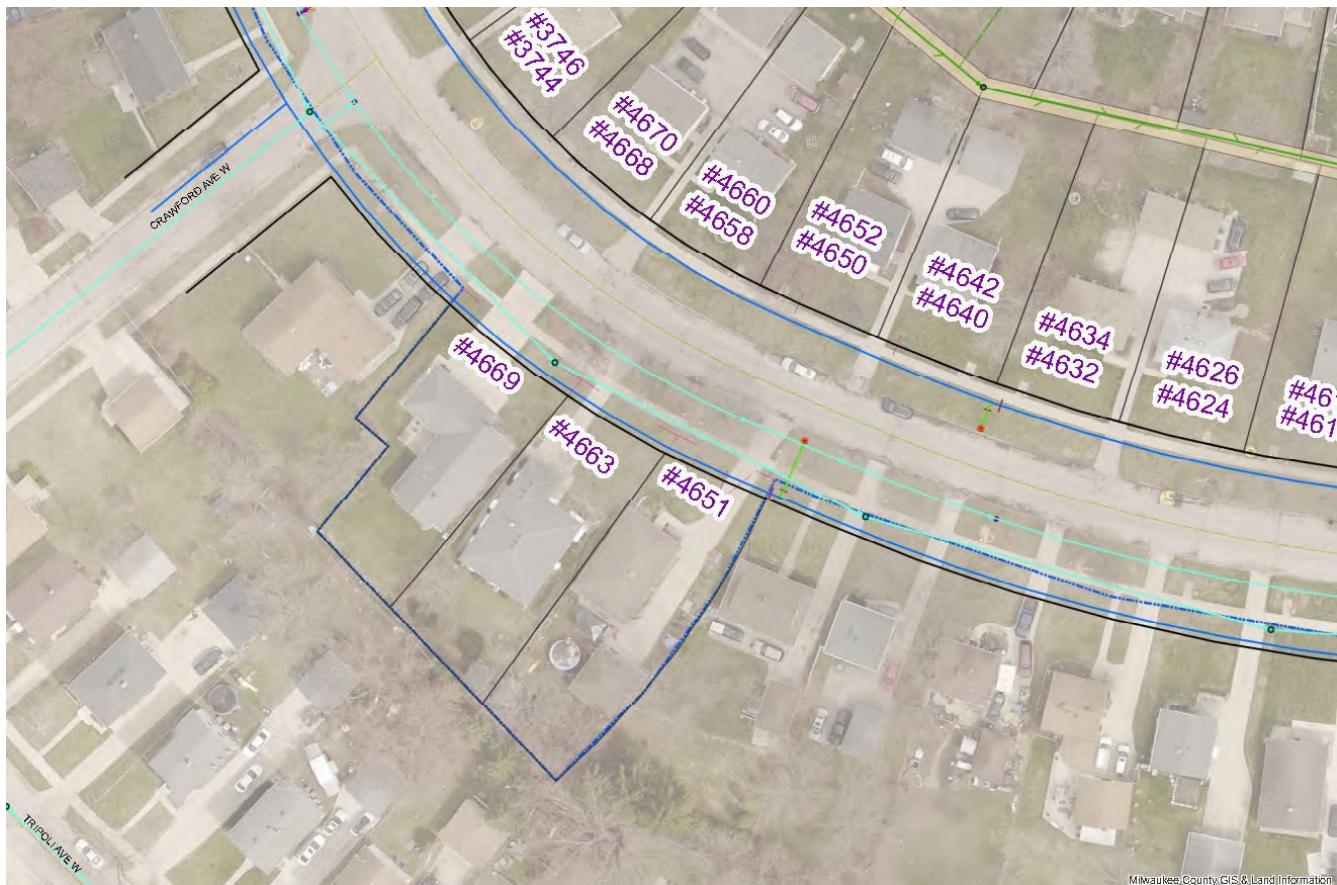
## Event 7

A notification form the City of Milwaukee about a Milwaukee dye testing effort at 4651/4663 W Crawford Ave. The dye testing effort follows smoke testing that suggested a potential issue at the house. Because this property is in Greenfield, but connects to a Milwaukee sanitary sewer, Greenfield was asked to assist Milwaukee during the dye testing effort in an effort to help gain access into the house. So far, the owner has been non-responsive, however the effort is on-going.
